COPIC, Denver, Colorado

EnCon Renew acted as a specialty repair subcontractor providing concrete structural repair, reconstruction, and caulking services to the COPIC parking structure in an effort to refurbish damage caused by water infiltration and freeze thaw cycles. An incomplete drainage plan created regular ponding and overflow in a corner of the deck with repeated exposure to moisture and deicing salts, leading to spalling of the concrete on the underside of a significant structural member. Constant movement of the concrete, due to temperature cycles and water exposure, creates an extremely harsh environment for any material. To reduce these issues, a revised drainage plan using a new custom gutter system facilitated proper drainage and water management.

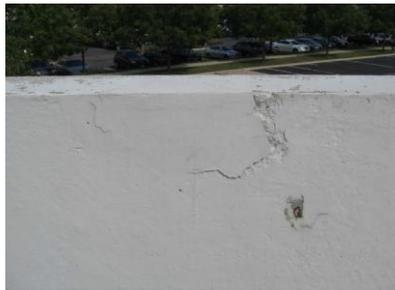
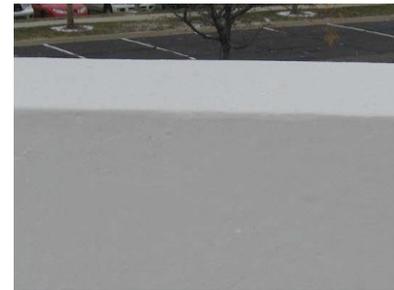
All lifting loop locations on spandrels above the top parking level showed signs of distress with crack lines around the perimeter of existing patch material, and were repaired with concrete patching.

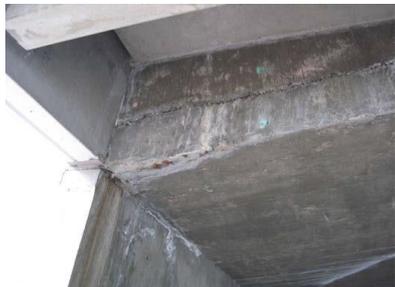
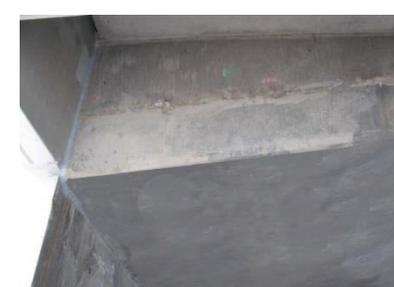
Loose concrete on the underside of the cast-in-place ramp edges was removed and repaired.
