Grandview High School, Aurora, Colorado

EnCon Renew acted as a general contractor providing concrete structural repair, reconstruction, and enhancement services to Grandview High School's entrance bridge as a measure to refurbish damage caused to a double tee and internal steel reinforcement. Exposure to repeated deicing, salts, moisture, and freeze thaw cycles created expansion and contraction over time. These constant cycles caused divarication of the double tee, and eventually led to cracking and deterioration, and potential failure. Constant movement on the concrete caused quicker erosion of the bearing area, which can be a life safety issue.

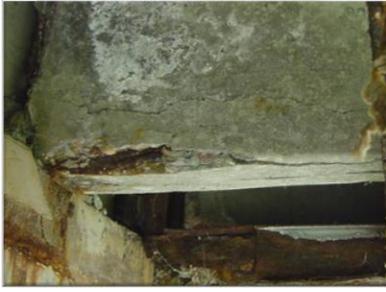
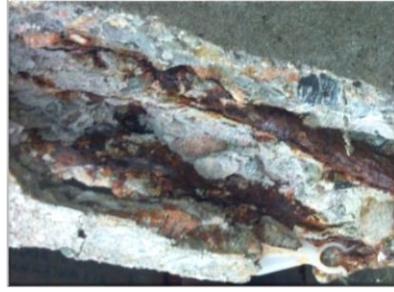
It can be seen that there is significant deterioration of both support elements.

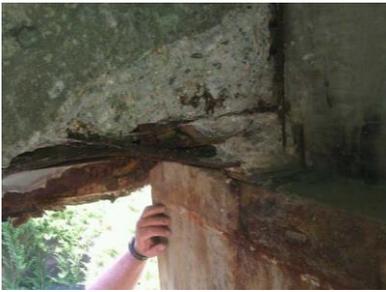
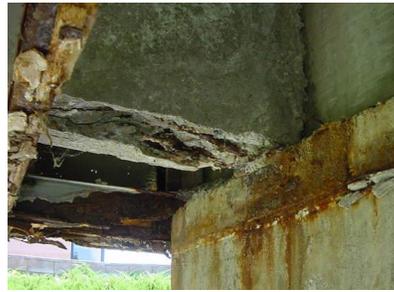
Long term exposure to deicing salts, moisture, and freeze thaw cycles causes concrete to become brittle, soft, and crack prone.
